Rock slope stability studies in Siskiyou National Forest

Greg Visconty
Portland State University

AN ABSTRACT OF THE THESIS OF Greg Visconty for the Master of Science in Geology presented May 20, 1988.

Title: Rock Slope Stability Studies in Siskiyou National Forest.

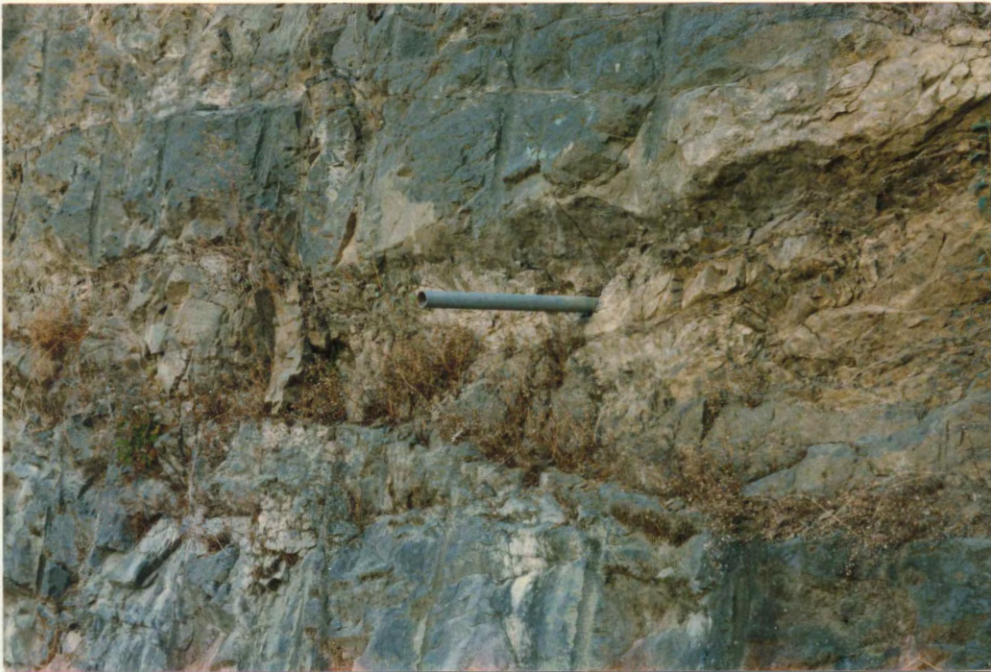
Figure 9. Drain installed in small fault.

generate large forces, causing seemingly stable slopes to fail during wet seasons. Year round climatic conditions need to be considered when analyzing rock slopes, and part of the final failure prevention plan may include drains for these water filled cracks. Figure 9 shows a drain pipe installed in the bottom of a moderately dipping fault plane.

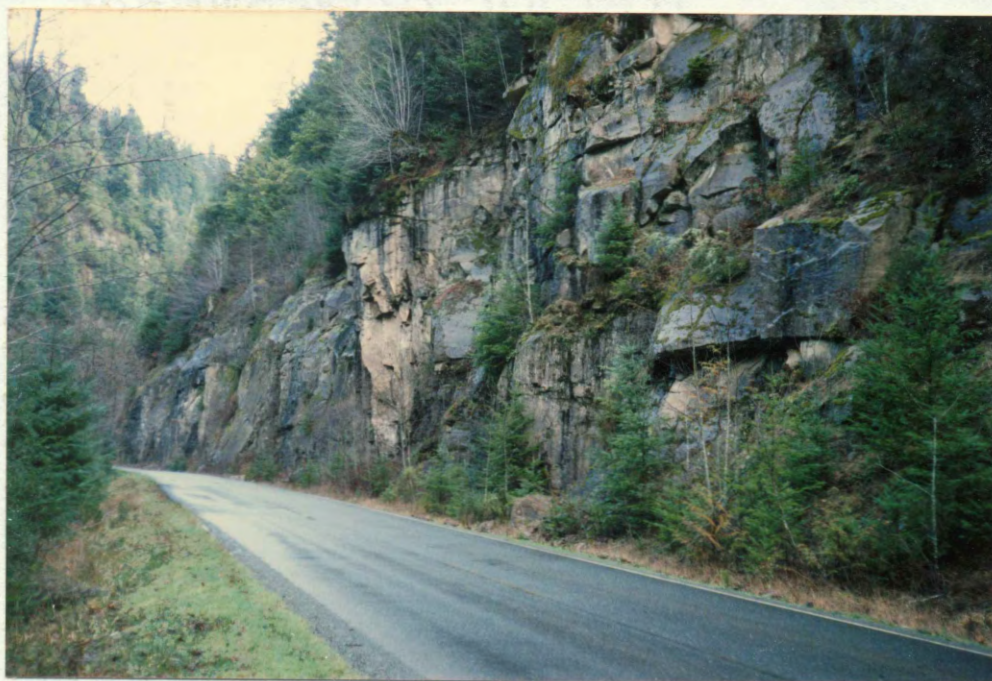
The Powers study site is located on National Forest Road 33, approximately nine kilometers south of the town of Powers at milepost 56.5, (see Figure 21). It is a 300 meter long section of road cut (Figure 23) in the Tyee Formation, consisting mostly of fine to medium grained sandstone. The rock is gray in color where fresh, but the exposed surface weathers to buff. Its bedding is locally near horizontal, but dips up to 15 degrees were recorded. The sandstone is interbedded with one to five meter thick beds of loadcasts (Figure 24) consisting of loosely packed and poorly cemented, layered, brown silty sandstone surrounding coarser gray spherical to ovoid sandstone cores. Periodically, these cores fall out, relatively intact, ranging in size up to one meter in diameter. One of these exposed loadcast beds underlies a section of the outcrop. This bed will erode at a faster rate than the overlying sandstone because it is considerably softer than the sandstone. Consequently, the sandstone will eventually be undercut, possibly causing collapse and/or toppling failure.

Figure 23. Powers road cut.

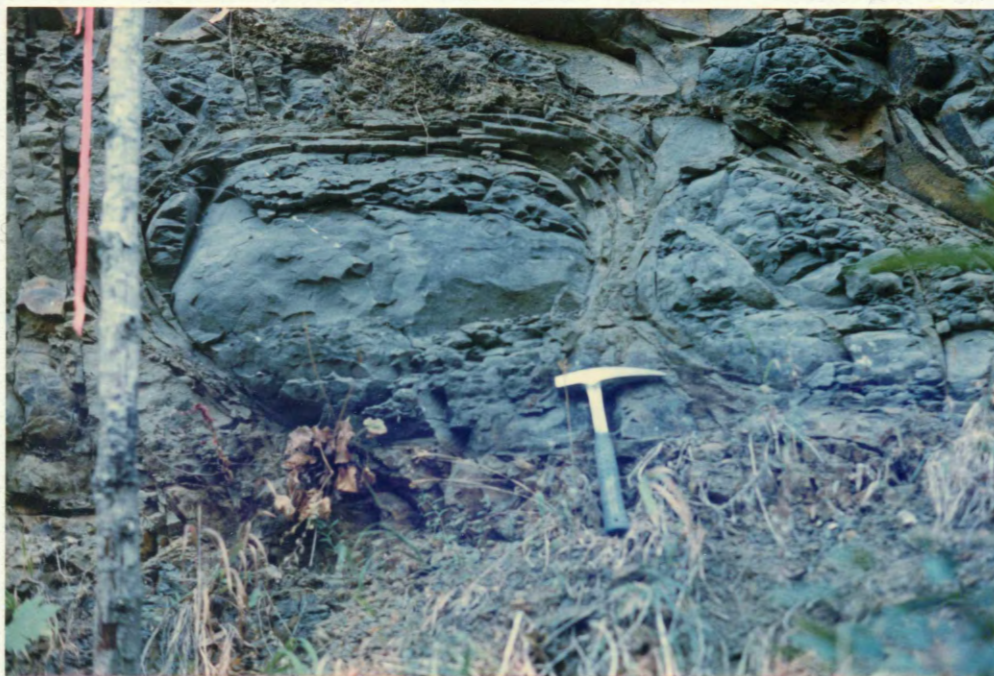
Figure 24. Load casts at Powers.

and potential failures were noted, prompting the choice of this road cut for analysis. That rocks do indeed fall here and present a hazard to traffic is evidenced by the presence of fallen load casts, and can be seen by the sandstone embedded asphalt shown in Figure 26. Many of the joints in the cliff face are open, some exceeding ten centimeters in width.

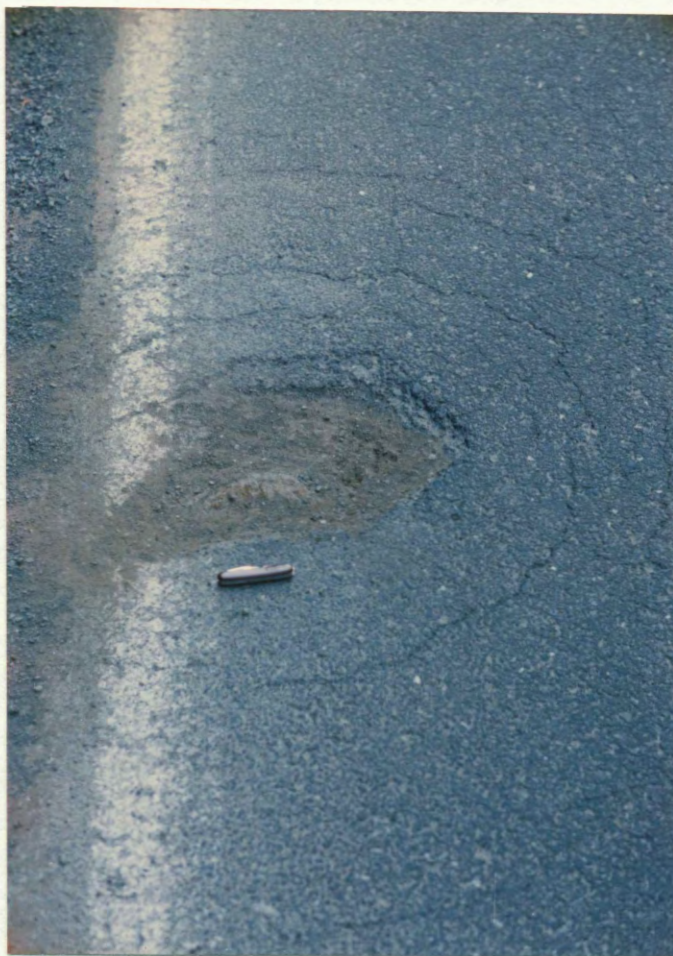
Figure 26. Sandstone in asphalt at Powers.

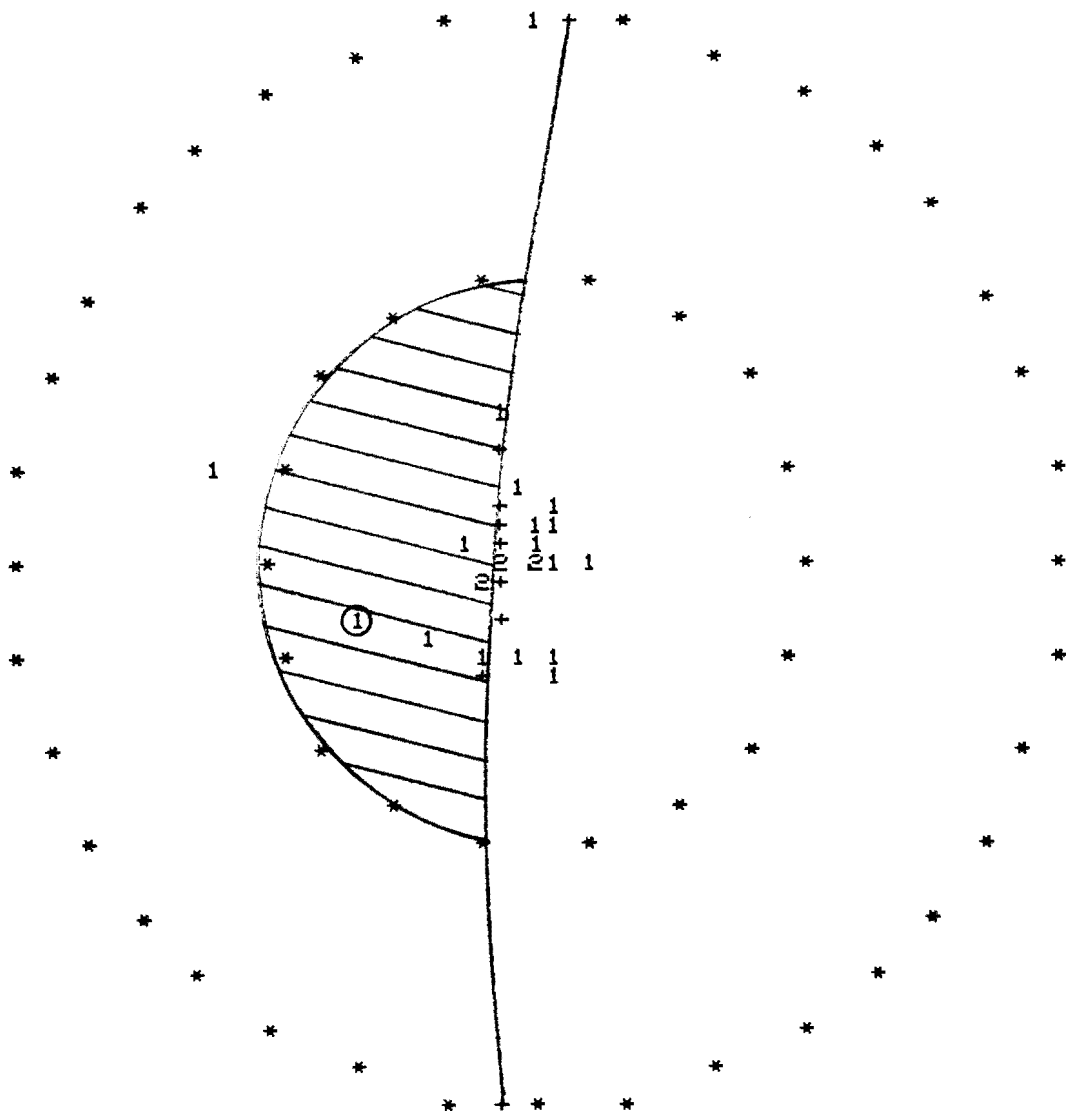
MARKLAND STABILITY PLOT

PLANE FAILURE

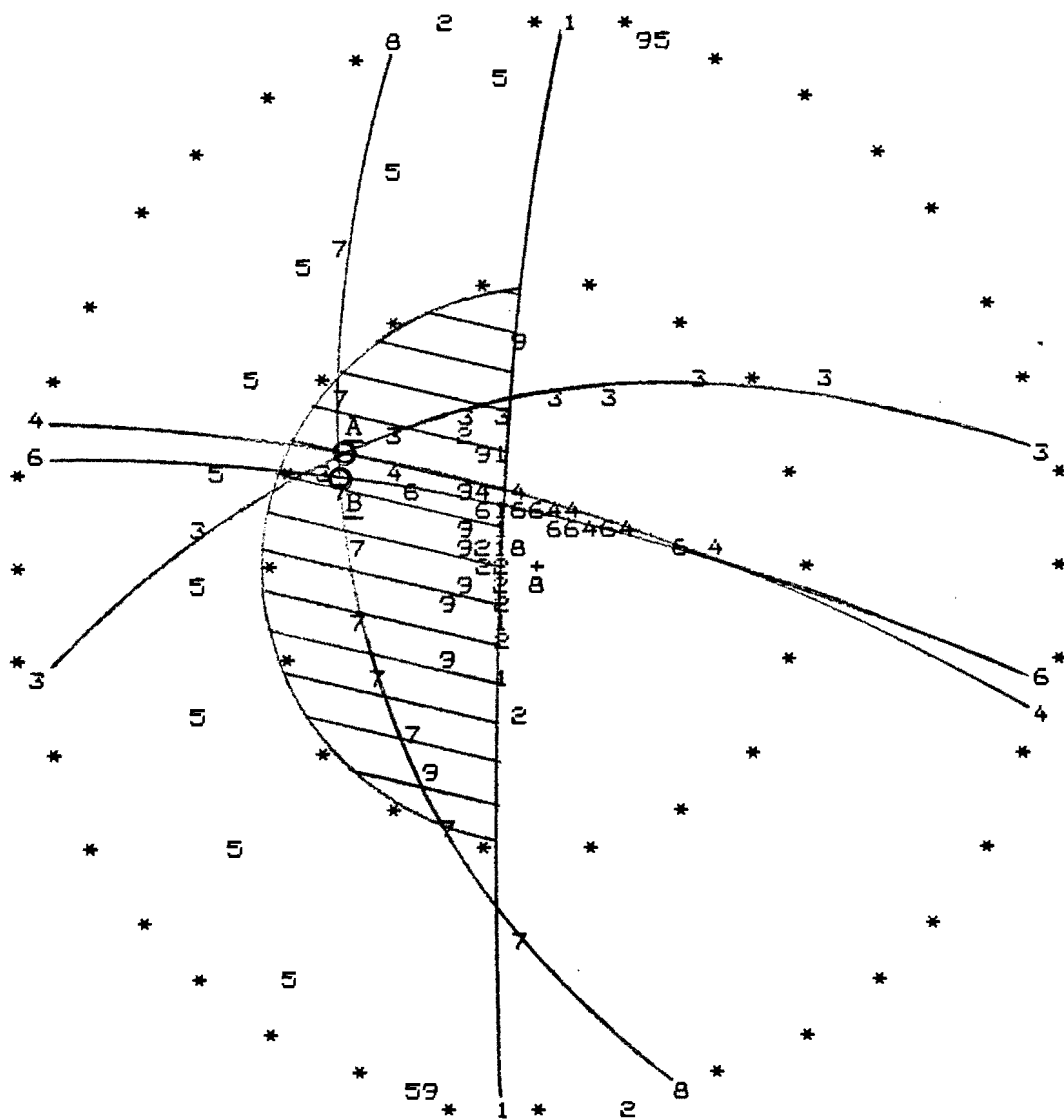
The structures longer than five meters were then plotted on stereonet as strikes and dips in the Markland Wedge test, as shown in Figure 29. Several great circle

intersections occur within the shaded critical area, but after considering the spatial locations of each in the field, only two intersections presented any real hazard potential; planes 3 and 4, and 6 and 7. Each intersection is circled in Figure 29, and labeled A and B, respectively. Calculations for intersection A, assuming no cohesion and dry surfaces, resulted in a Factor of Safety of 2.38. By saturating the wedge planes for the worst possible water conditions, the water pressure on each plane reached 41 kPa, and the Factor of Safety dropped to 0.13, with contact maintained only on the shallower dipping plane. In order to maintain stability for this wedge, a cohesive value of 22 kPa is required. Calculations for intersection B resulted in a Factor of Safety of 1.12. With a water pressure of 41 kPa on each plane, contact would be maintained only on the shallower dipping plane, and the Factor of Safety would drop to 0.19. Cohesion of 130 kPa would be required to prevent this wedge from sliding. It must be noted that one plane of this wedge is the plane of the slab discussed in the plane failure analysis above. Essentially, this slab is cut by a plane to form a wedge at its northern end, and both the slab and the wedge would probably fail simultaneously.

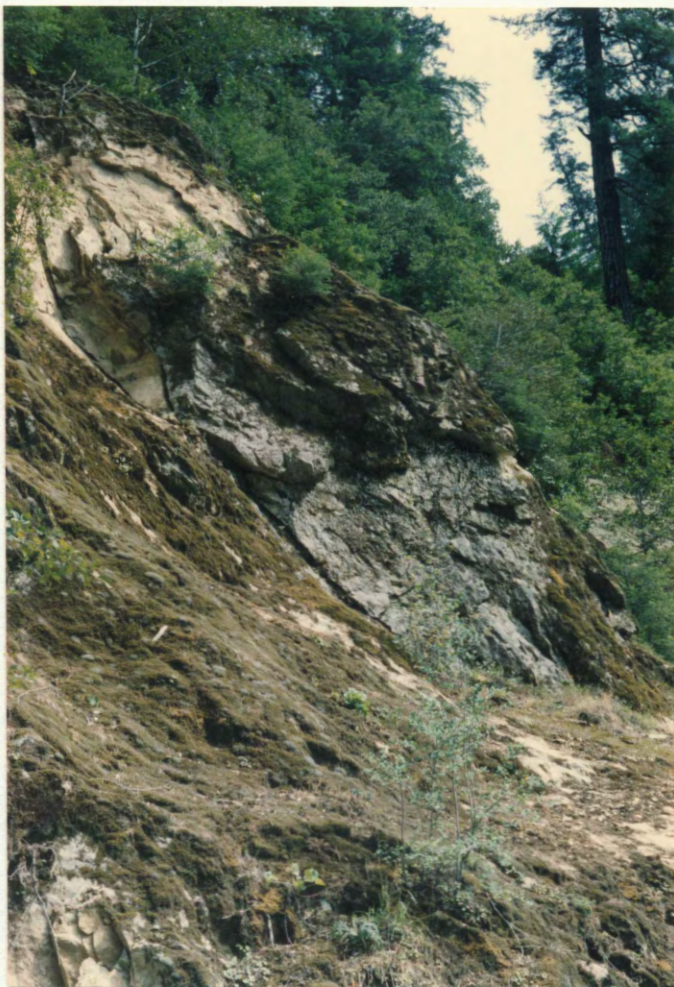
The first of two faults in this outcrop cuts through Elk 3, and has a curvilinear characteristic, with dips ranging from 40 to 74 degrees northwest. Its strike is 151 degrees. Due to its curved nature, the 40 degree (shallower) dip will control stability. Perched on this surface are two slabs, approximately four meters above the road; at 7.0 meters, shown in Figure 37, and at 14.0 meters, shown just to the right of center in Figure 38. As in Elk 2, the internal angle of friction for this fault plane is estimated at 22 degrees. A vertical joint set, mapped at Elk 1 and striking at 30 degrees, can be seen up the slope face, and will act as the release plane for both of these slabs. When dry, the Factor of Safety for the first slab is 1.04, and 1.07 for the second slab. When fully saturated, these values drop to -.30 and -.09, respectively. The cohesive value for the first slab is 184 kPa, and for the second is 168 kPa. As can be seen in Figures 37 and 38, these slabs are loose and have already moved a small amount, and are the most hazardous features of this outcrop. In addition to their conditions, should they fail, they would land directly on the road below.

Figure 37. First fault perched slab of Elk 3.
